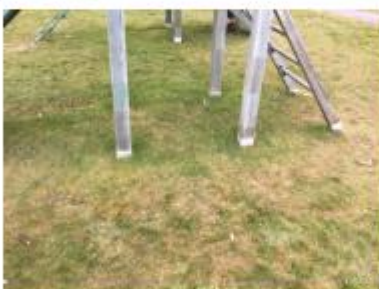
Covers on timbers to protect against strimmer damage have been known to retain moisture, accelerate timber decay and prevent inspection.

Read the notes for further action.

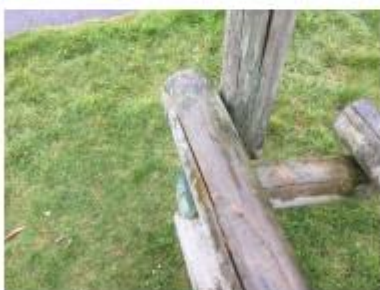
Fixtures loose or missing.

Top rail loose at upright.

Risk level:
Medium

Tighten.

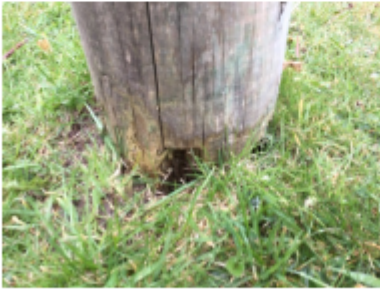
Timber is rotting.

Stepping log.

Replace rotten timbers.

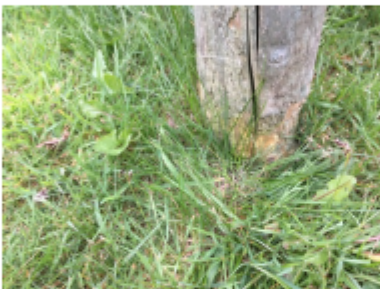
Strimmer damage to supports is likely to accelerate timber rot.

Prevent further damage.

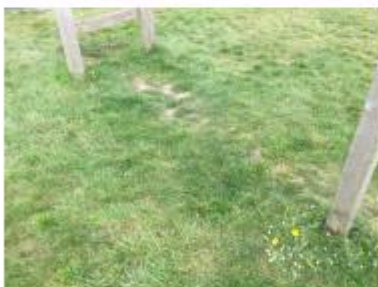
Suitably well maintained grass and topsoil with at least 150 mm of soil beneath is acceptable to EN 1176 for items with a fall height of up to 1.5 metres, subject to a risk assessment.

Monitor to maintain the grass in good condition.

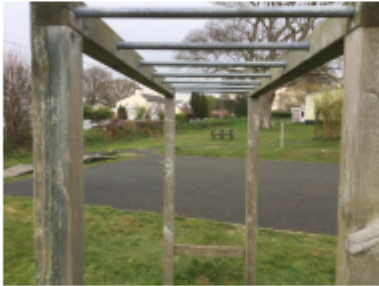
RoSPA is concerned by accidents on some types of overhead ladders and rings. However, there is a strong development value in these items.

The protective surface under all bars and rings must be kept in good condition.

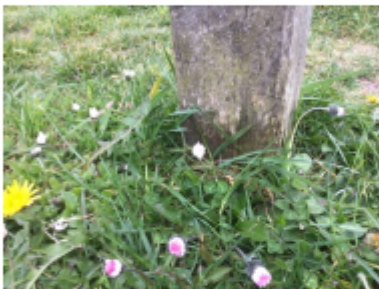
Strimmer damage to supports is likely to accelerate timber rot.

Prevent further damage.
