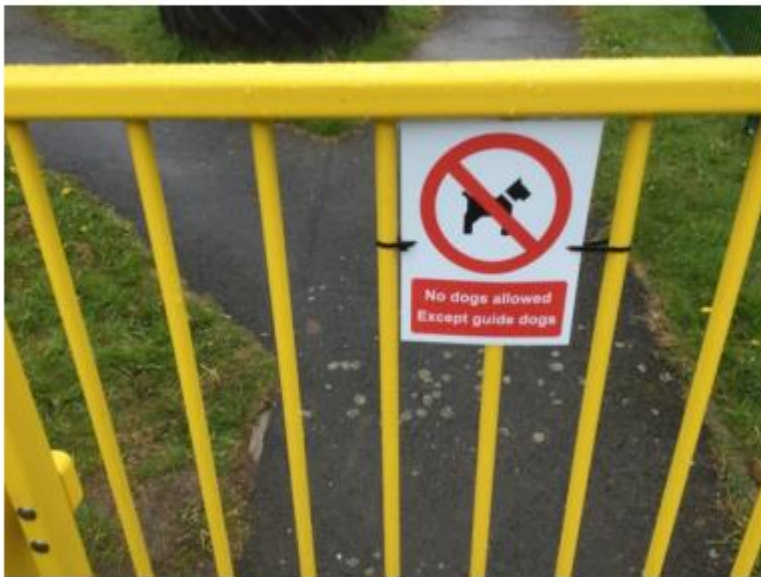
Signage - Dog Ban

Risk level: ■ Very low

Ownership details are recommended.

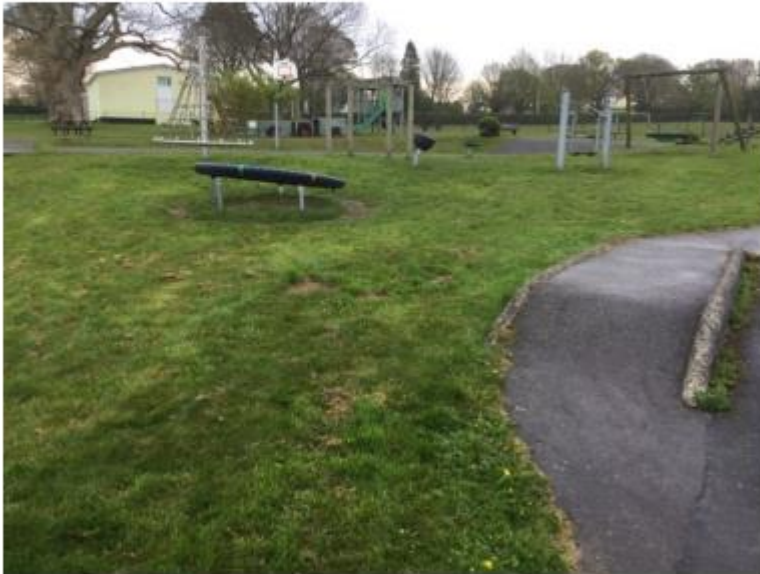
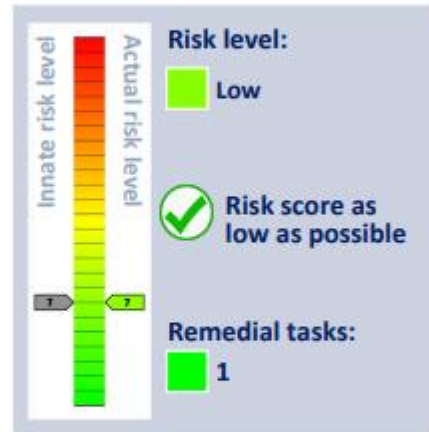
The Overall Site

Covers on timbers to protect against strimmer damage have been known to retain moisture, accelerate timber decay and prevent inspection.

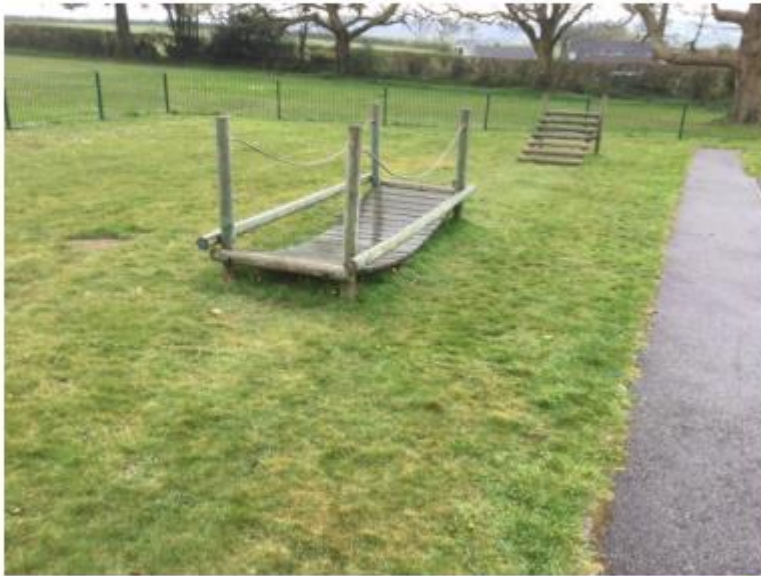
Balance Trail - Log

Risk level:
Medium

Fixtures loose or missing.

Top rail loose at upright.

Timber is rotting.

Stepping log.

Strimmer damage to supports is likely to accelerate timber rot.

Tighten.

Replace rotten timbers.

Prevent further damage.

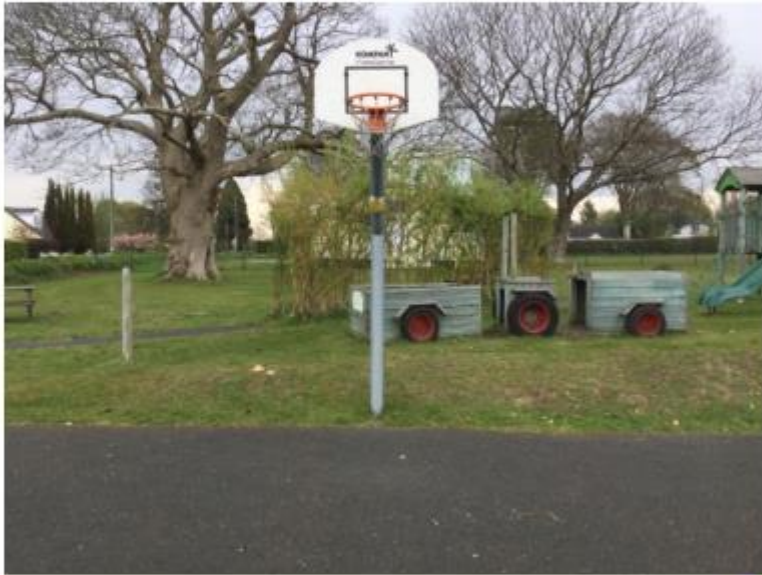
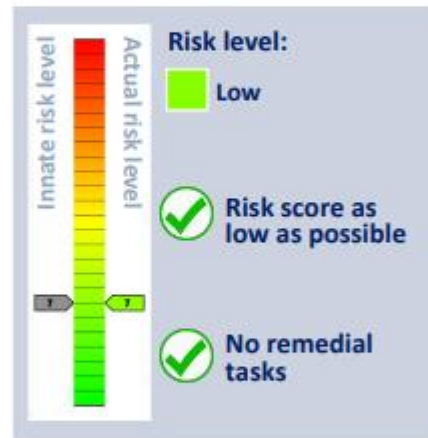
Basketball Post

The item and its surfacing (where applicable) meet with the requirements of the relevant standards.

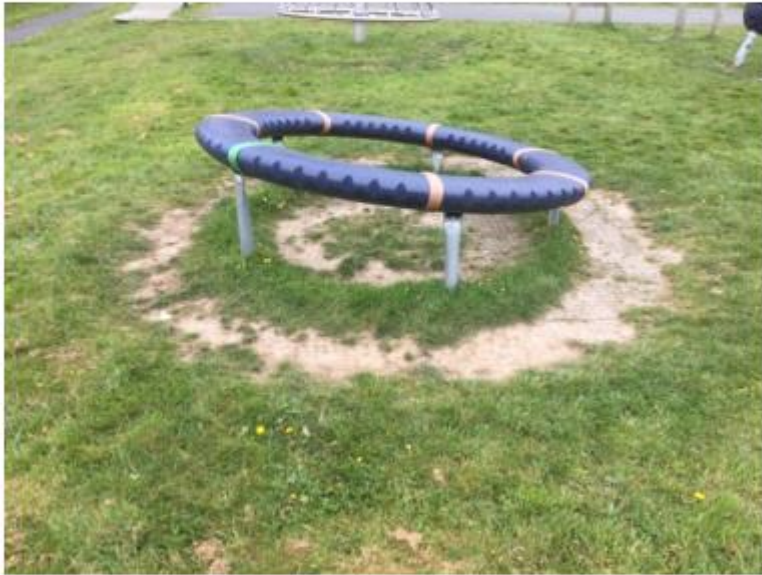
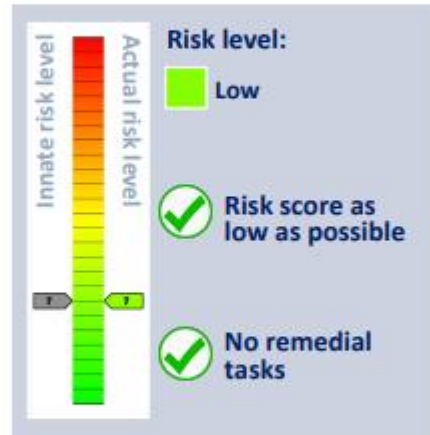
Carousel - Supernova

The item and its surfacing (where applicable) meet with the requirements of the relevant standards.

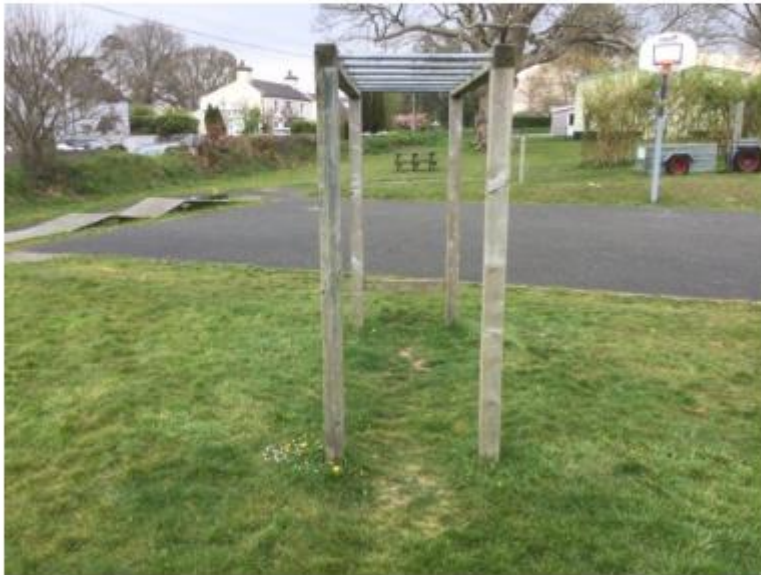
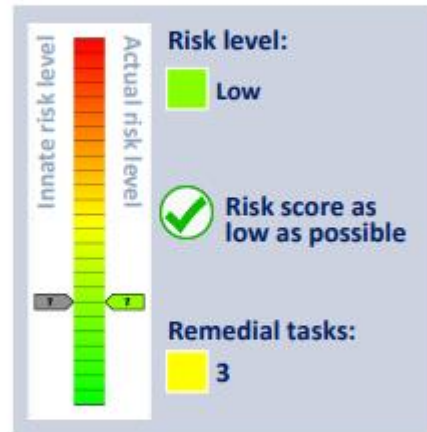
Climber - Overhead - Ladder

Suitably well maintained grass and topsoil with at least 150 mm of soil beneath is acceptable to EN 1176 for items with a fall height of up to 1.5 metres, subject to a risk assessment.

RoSPA is concerned by accidents on some types of overhead ladders and rings. However, there is a strong development value in these items.

Strimmer damage to supports is likely to accelerate timber rot.

Monitor to maintain the grass in good condition.

The protective surface under all bars and rings must be kept in good condition.

Prevent further damage.

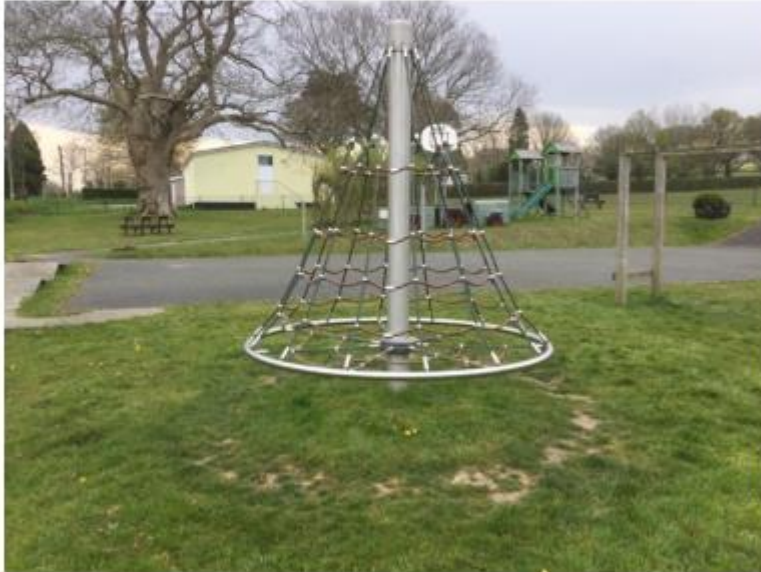
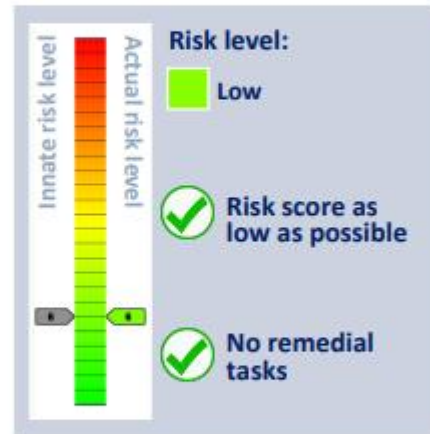
Climber - Rota Web

The item and its surfacing (where applicable) meet with the requirements of the relevant standards.
